# **INDOOR AIR QUALITY ASSESSMENT**

**Elm Street School  
415 Elm Street  
Walpole, Massachusetts**

Prepared by:  
Massachusetts Department of Public Health  
Bureau of Environmental Health Assessment  
Emergency Response/Indoor Air Quality Program  
November 2003

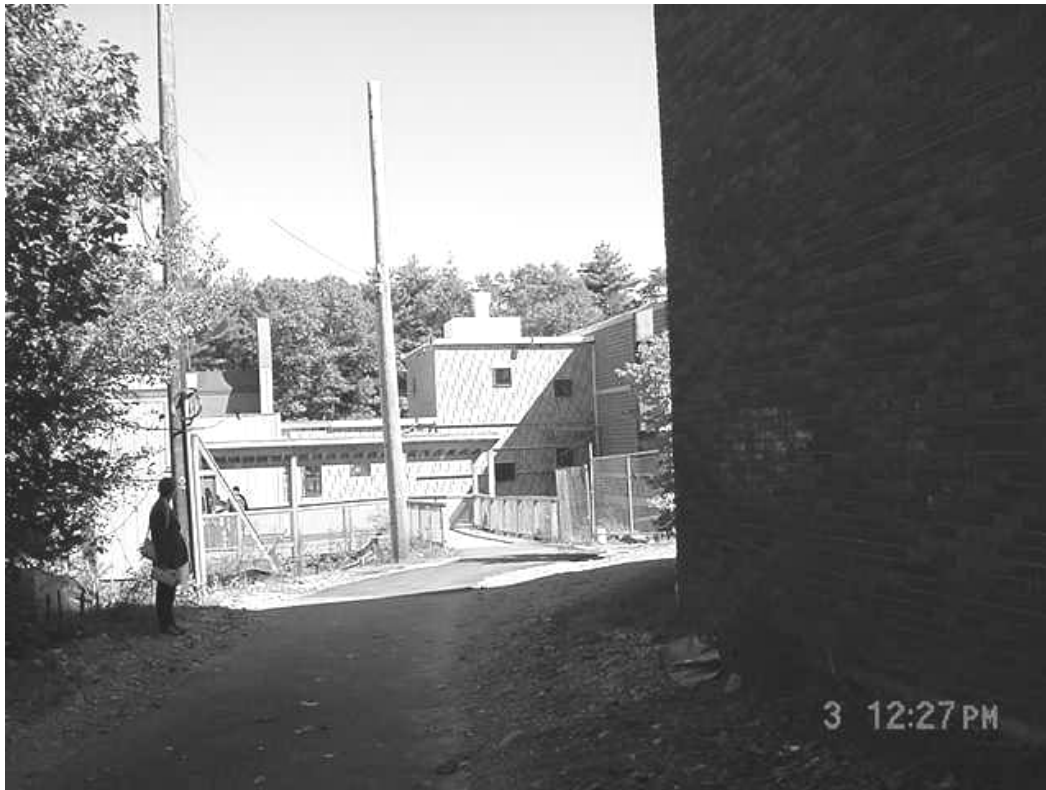
**Picture 1**

**New Addition Constructed between the Front (Right) and Back (Left) Wings**

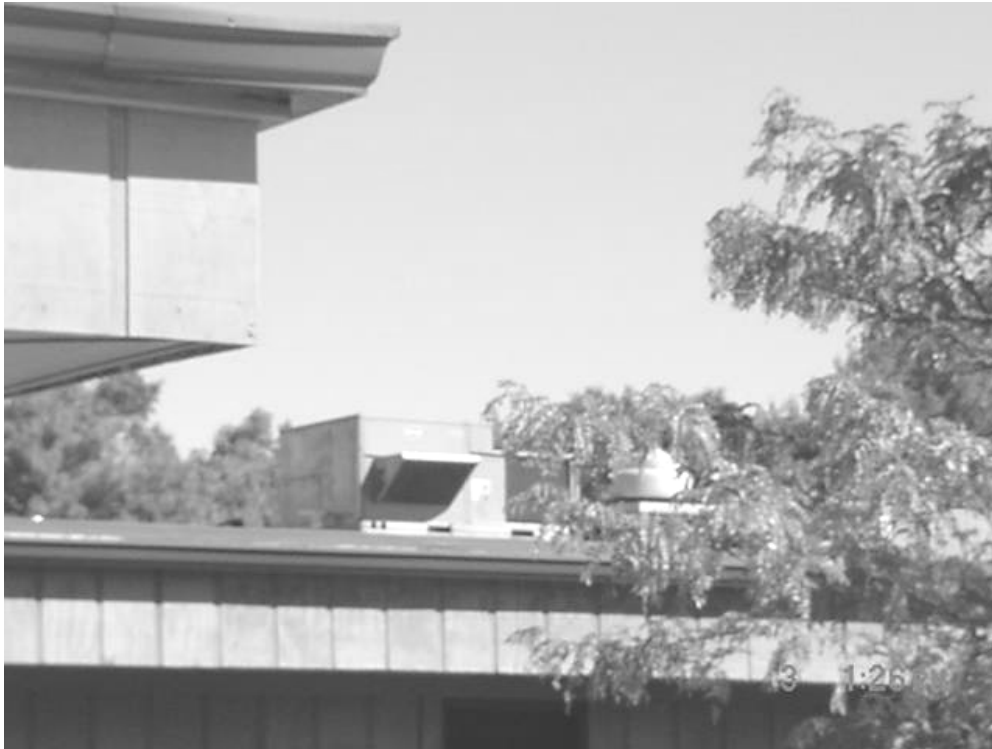
**Picture 2**

Mechanical ventilation is provided by rooftop air handling units (AHUs) (Picture 2). Fresh air drawn into outside air intakes and distributed via ductwork connected to ceiling or wall-mounted air diffusers (Picture 3). Exhaust ventilation is provided by ceiling or wall-mounted exhaust grills that are ducted back to AHUs (Picture 3). It was reported by school officials that during the assessment several rooftop air handling units (AHUs) were not operating.

**Rooftop AHU**

To maximize air exchange, the BEHA recommends that both supply and exhaust ventilation operate continuously during periods of occupancy. In order to have proper ventilation with a mechanical ventilation system, the systems must be balanced subsequent to installation to provide an adequate amount of fresh air to the interior of a room while removing stale air from the room. The date of the last balancing of these systems was not

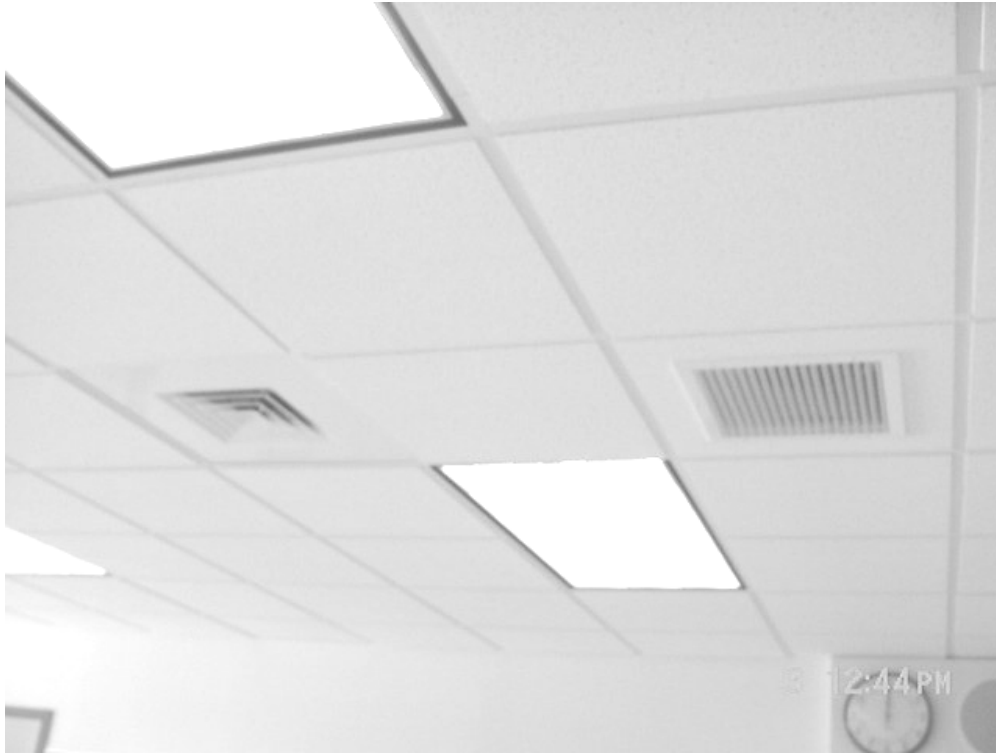
**Picture 3**

**Ceiling-Mounted Supply (Left) and Exhaust Vent (Right)**

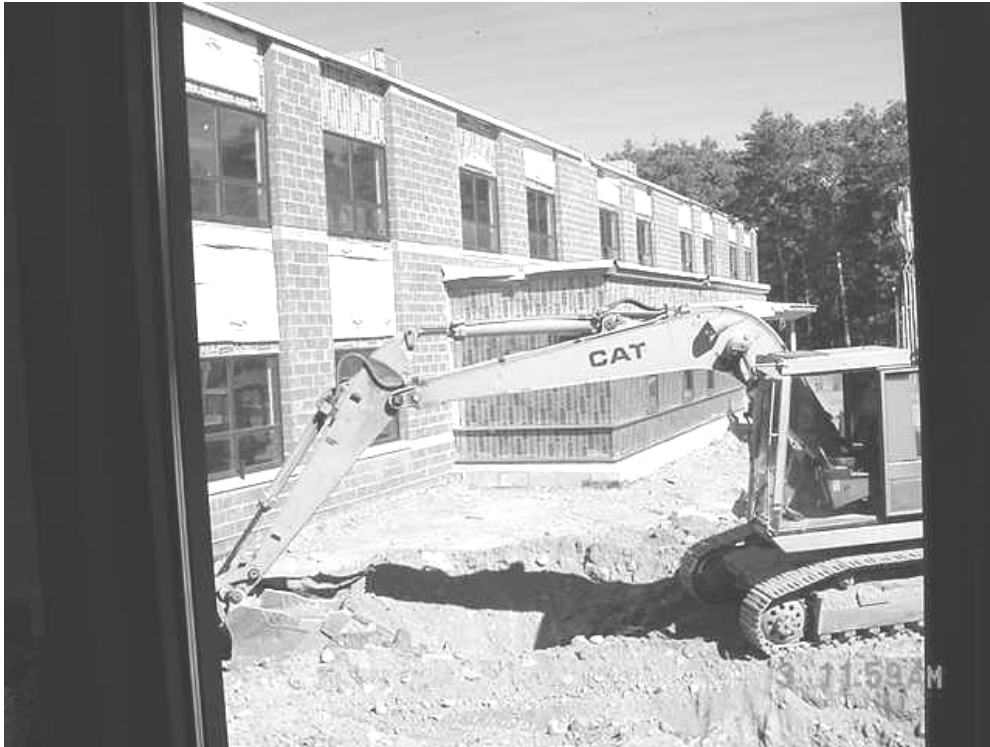
**Picture 5**

A number of construction vehicles and several large piles of dirt/construction debris were observed around the perimeter of the building. This activity should be closely monitored to avoid the entrainment of vehicle exhaust and other construction generated pollutants inside the building via open doors or windows (Picture 5). A number of classrooms adjacent to the construction zone had open windows. The opening of windows allows for unfiltered air to enter the classroom environment carrying with it airborne dirt, dust and particulates. Dusts can be irritating to the eyes, nose and respiratory tract. Other pathways were observed for construction-generated pollutants to enter occupied areas of the building. The construction barrier in the main hallway had two holes near the top (Picture 6) and some were only partially sealed (Pictures 7 & 8). Open utility holes were seen in several of the walls separating occupied areas from construction zones (Picture 9). Finally, spaces were noted beneath the side entrance doors (Picture 10).

**Construction Vehicle in Close Proximity to Building**

4. Continue to schedule projects which produce large amounts of dusts, odors and emissions during unoccupied periods or periods of low occupancy.
5. Cover dirt/debris piles with tarps or wet down to decrease aerosolization of particulates, when possible.

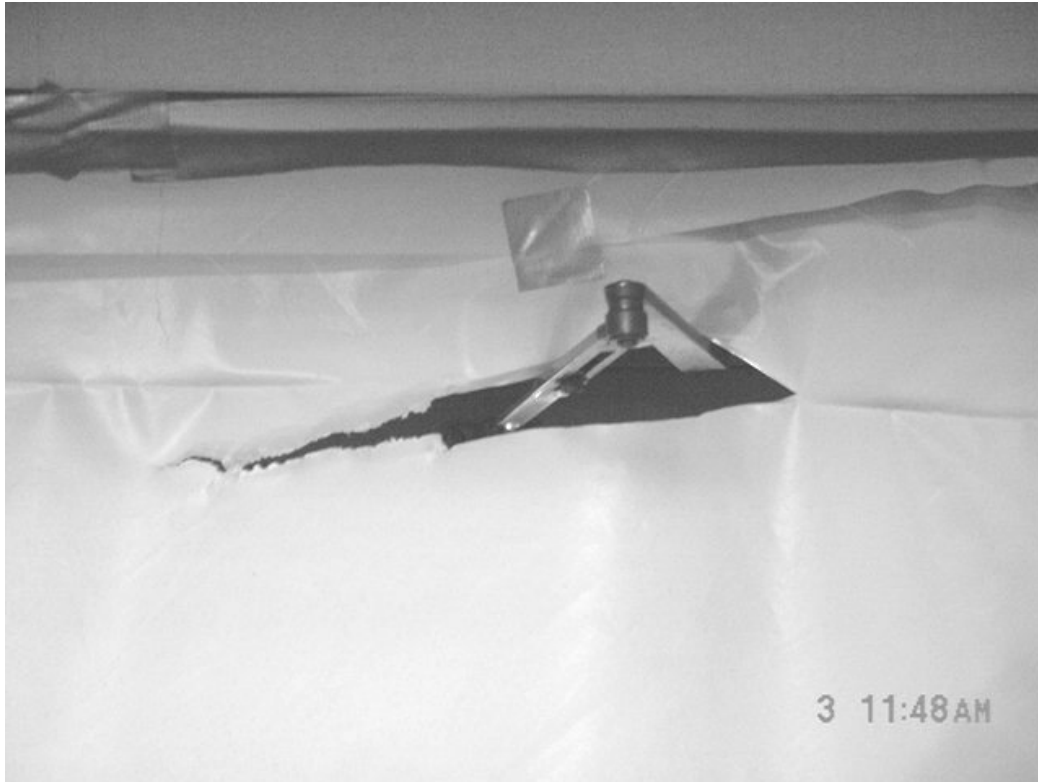
**Picture 6**

**Hole in Top of Containment Barrier for Door Hinge**

10. Seal around exterior doors with weather stripping and door sweeps. Seal construction barriers on all sides with polyethylene plastic and duct tape. Seal these barriers on the construction as well as the occupied side to provide a dual barrier. Inspect these areas regularly as mentioned in the Plan to ensure integrity is maintained.

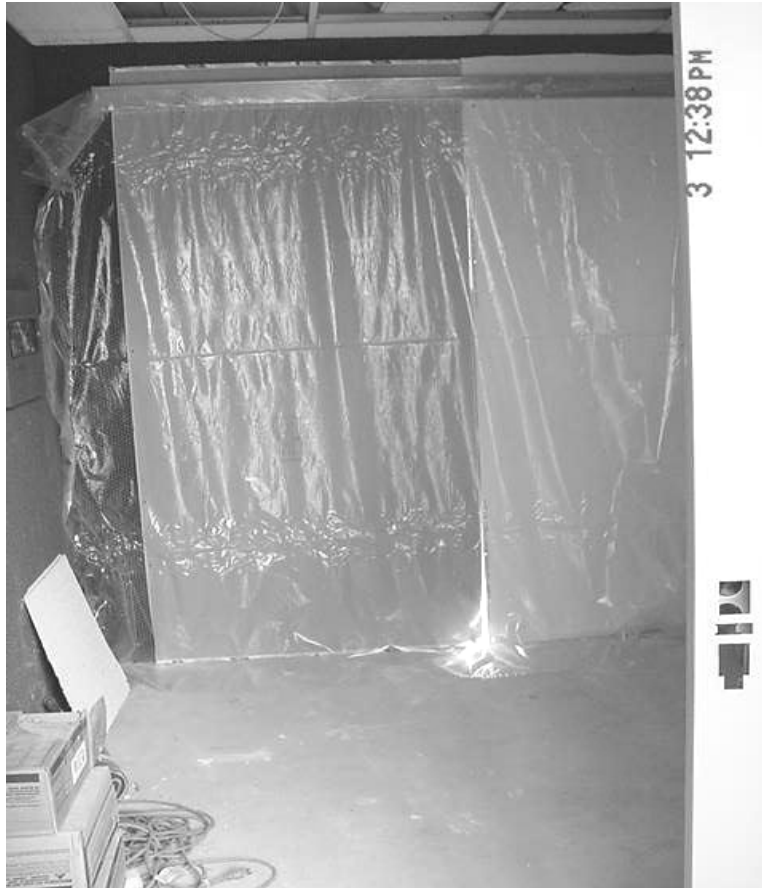
**Picture 7**

**Gypsum Wallboard Construction Barrier in Back Wing, Polyethylene Plastic Not Sealed**

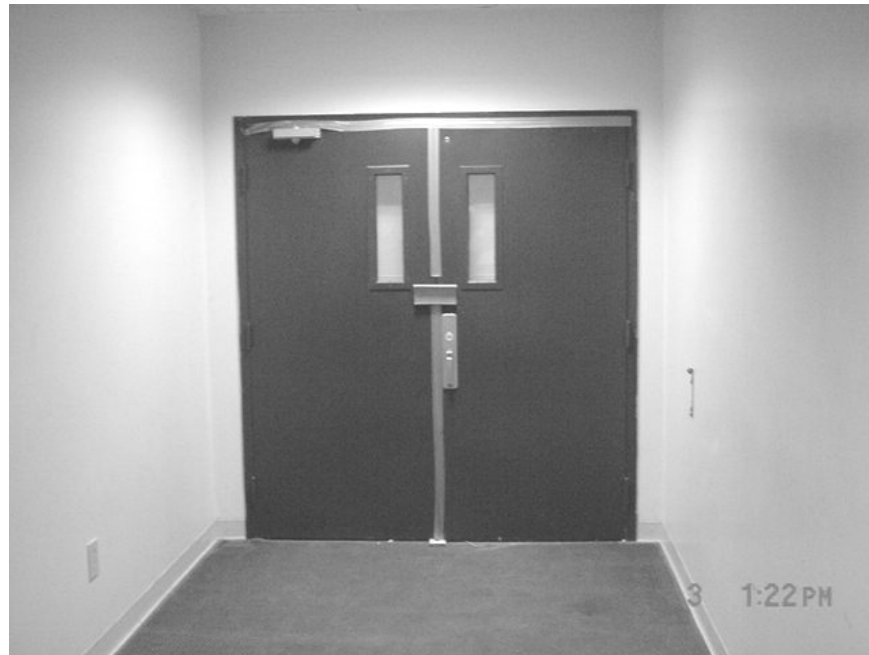
**Picture 8**

**Doors in Gymnasium Hallway Partially Sealed With Duct Tape**

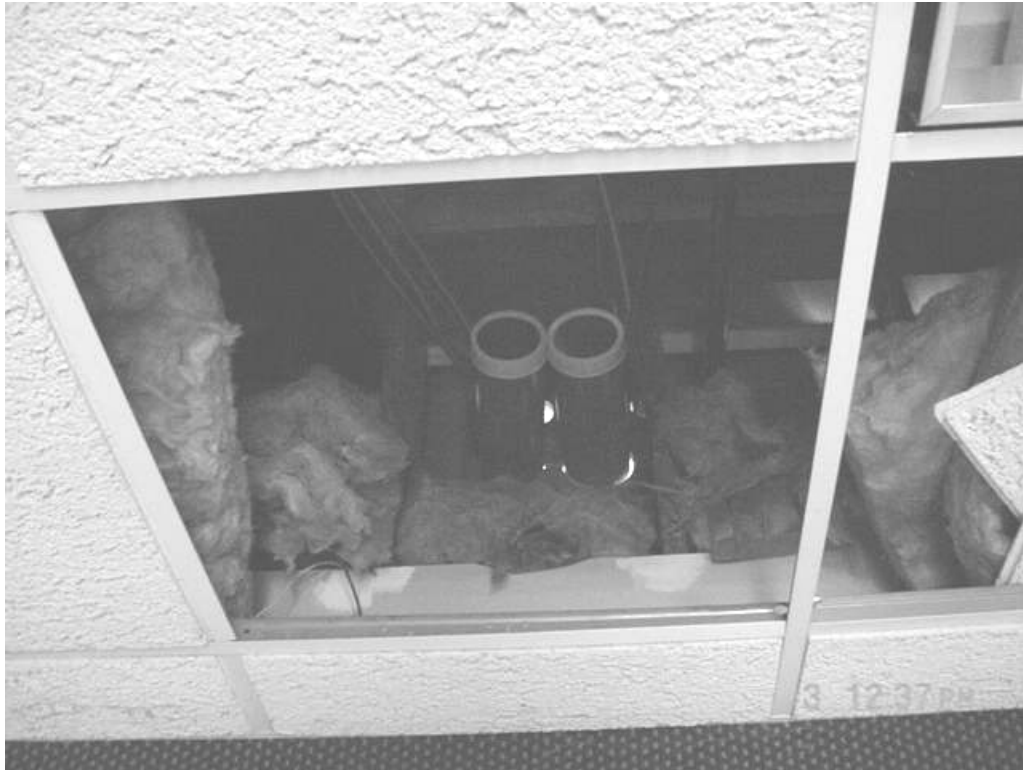
**Picture 9**

**Open Utility Pipes and Spaces around Pies in Wall Separating Construction/Occupied Areas**

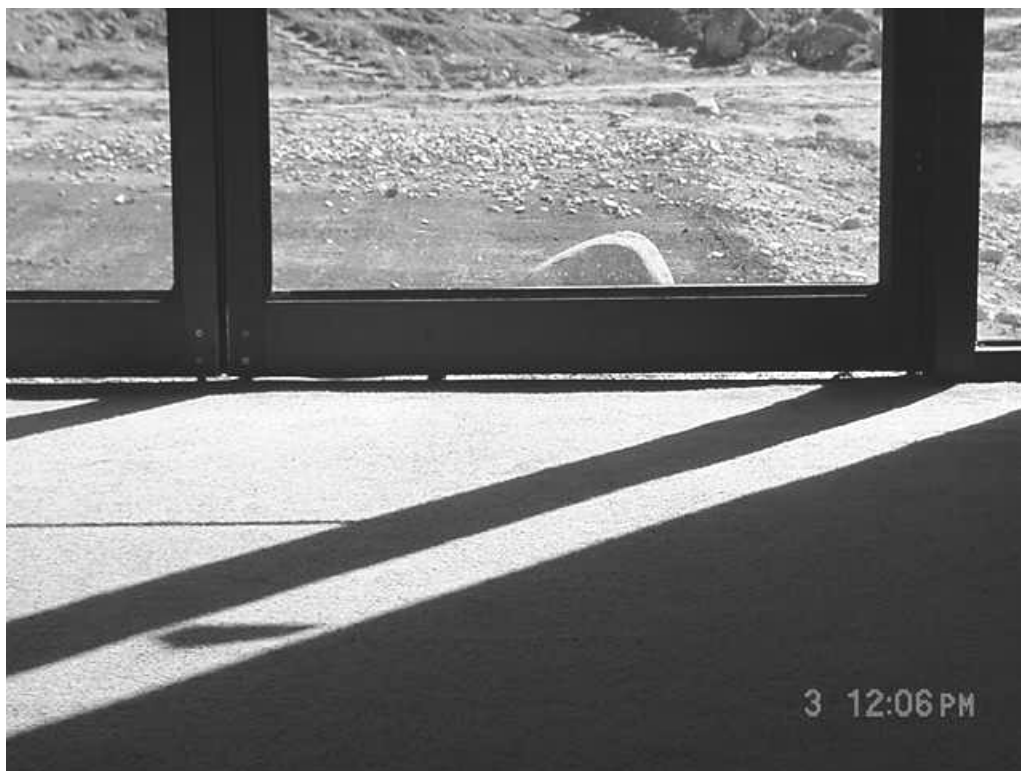
**Picture 10**

**Spaces beneath Side Entrance Doors**
